Manhole Inspection Summary

Manhole # S37I__004MH

Inspection ☐ Is Incomplete Rating: **4) Poor**

Location Address: **201 e pratt st**

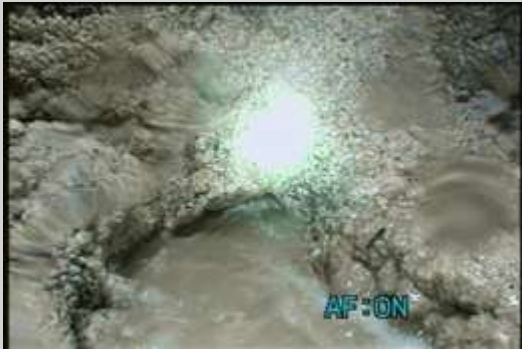
12 O'Clock Outflow

6 in. Circular Gravity Sewer
Pipe Out @ 12 O'Clock

Pipe Material: **Clay** ☐ Pipe Lined

Invert Depth: **9.00** (ft.) Flow Characteristics: **Fast**

Infiltration: **None** Pipe Seal Cond: **Unknown**

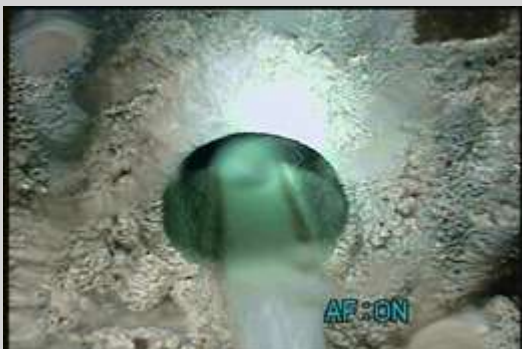
4 O'Clock Inflow

6 in. Circular Gravity Sewer
Pipe In @ 4 O'Clock

Pipe Material: **PVC** ☐ Pipe Lined

Invert Depth: **8.88** (ft.) Flow Characteristics: **Fast**

Infiltration: **None** Pipe Seal Cond: **Unknown**

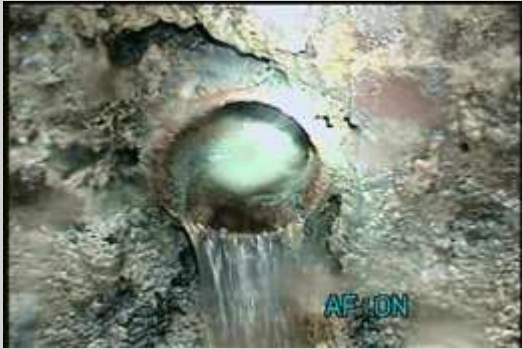
6 O'Clock Inflow

Pipe In @ 6 O'Clock

Pipe Material: **Clay** ☐ Pipe Lined

Invert Depth: **7.88** (ft.) Flow Characteristics: **Fast**

Infiltration: **None**

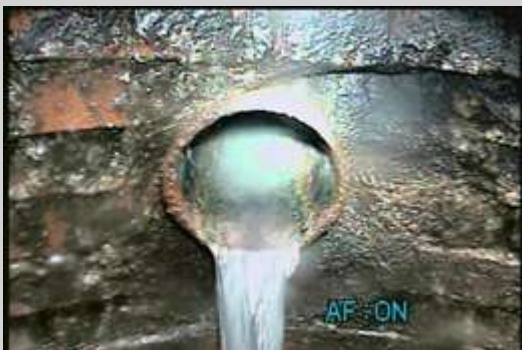
9 O'Clock Inflow

Pipe In @ 9 O'Clock

Pipe Material: **Clay** ☐ Pipe Lined

Infiltration: **None**
